MILLCREEK TOWNSHIP SEWER AUTHORITY

RE: Kearsarge Area Sanitary Sewer Overflow

We wish to outline the sequence of events that occurred at the Kearsarge pump station on Saturday, March 20, 2004, which resulted in a bypass for a period of 3.5 hours. There had been a substantial accumulation of snow remaining on the ground when the rainfall started in the early morning hours. The writer made two visits to the station, one before noon and one after 1:00 p.m. to observe the station operation. The light to moderate rain stopped between 12:30 and 1:00 p.m. Flows at the station were observed to be approximately 2,000 gpm on the meter at noon and 2,150 gpm at 1:00 p.m. Pumps were running at 65% at noon and at 70% at 1:00 p.m. (both pumps #1 and #2 were running). At 2:45 p.m. heavier rain started with thunder. The rain continued with similar intensity until approximately 3:30 p.m. when moderated with just a light rain at 4:00 p.m. At that time the writer was contacted by the Millcreek Township police who relayed a message from Dick Bridger, your maintenance supervisor, that the pumps at the pump station did not have sufficient capacity to keep up with the influent flows. The writer went to

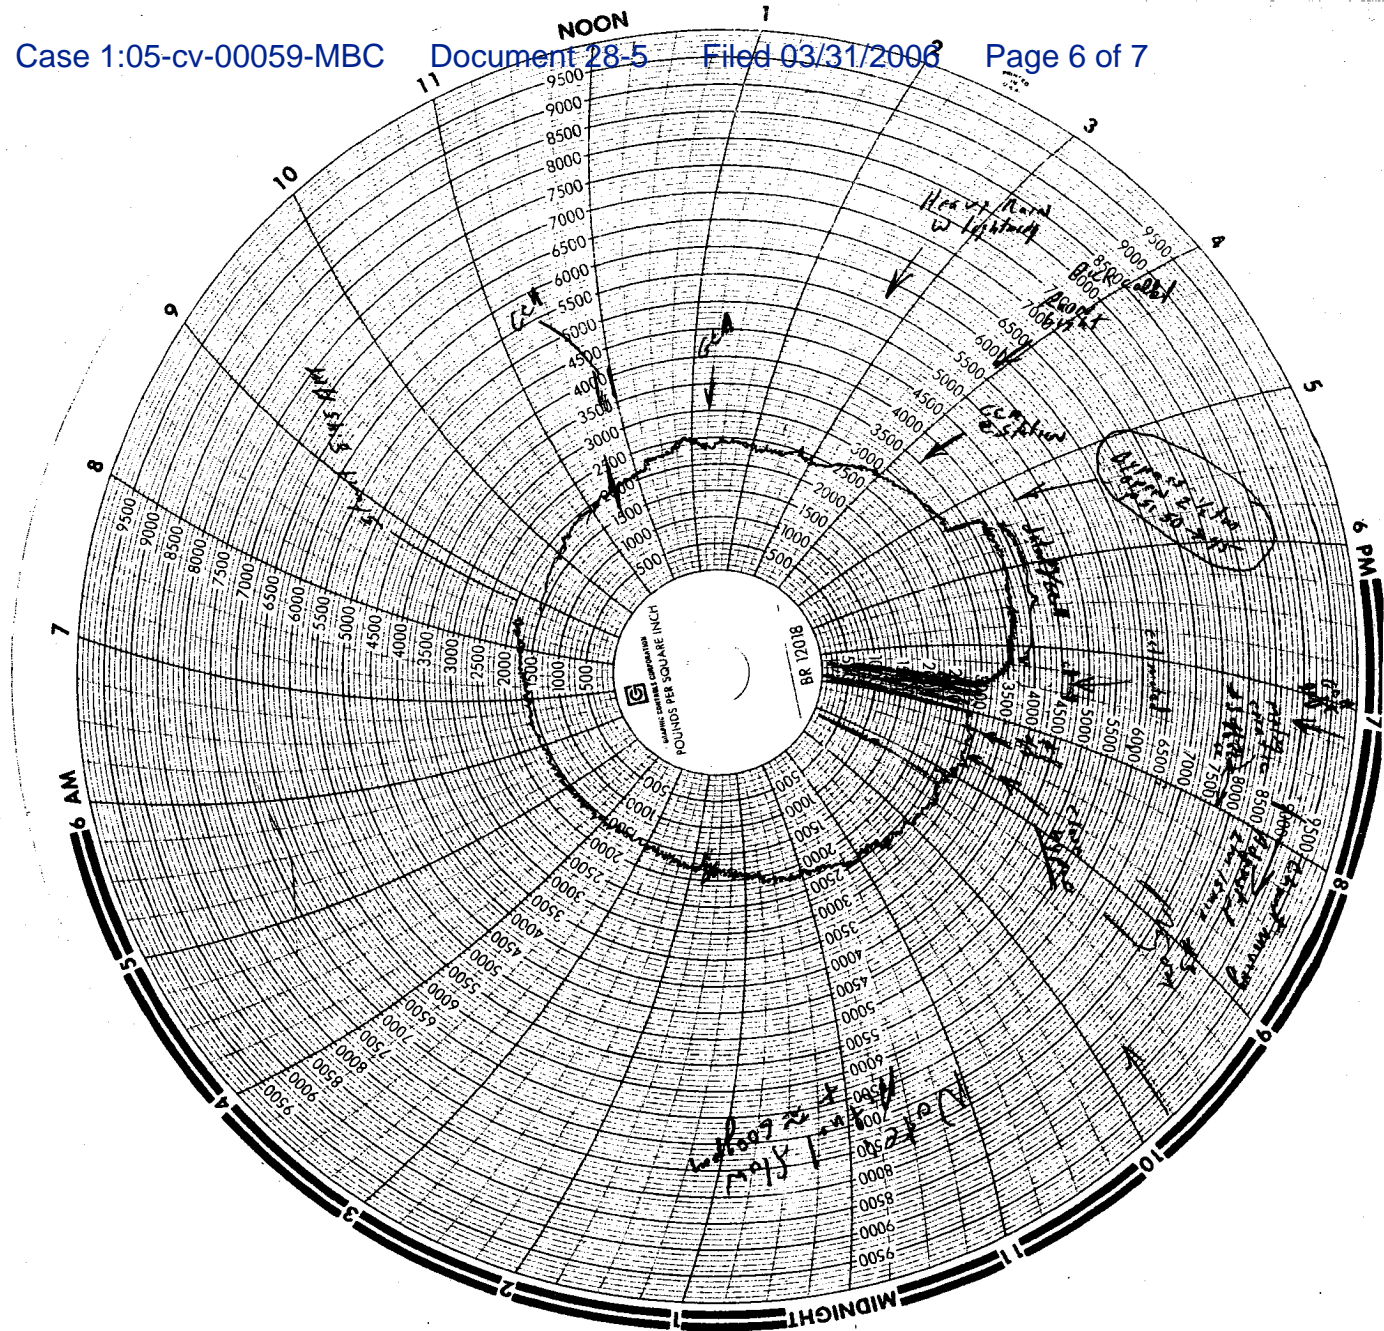
3/20/04 Reconstructed
Chart

The circular chart recording the flows interpreted by the meter had malfunctioned. For approximately two hours the chart moved slowly and as a result the data in that time frame was recorded within an approximate 20 minute interval on the chart. The chart did not begin moving again until levels dropped close to prestorm conditions. At that time the meter itself began to malfunction because the signal was lost most likely due to entrained air and it was not discovered that the meter had stopped moving until sometime after that at about the time the bypass was closed. At that time Mr. Snyder moved the chart to the proper time. Thus, on the enclosed chart, the time frame before and up to the beginning of the bypass is correct and the time following the closing of the bypass is likewise correct. We have enclosed a separate chart that we have constructed based first of all on the writer's observation and discussions with Mr. Snyder.
